NASA/TM-2007- 215084
NESC-RP-07-13/06-050-E

Independent Review Support for Phoenix Mars Mission Robotic Arm Brush Motor Failure

NASA Engineering and Safety Center Technical Report	Document #: RP-07-13	Version: 1.0
Title: Independent Review Support for Phoenix Mars Mission Robotic Arm Brush Motor Failure			Page #: 1 of 54

March 8, 2007

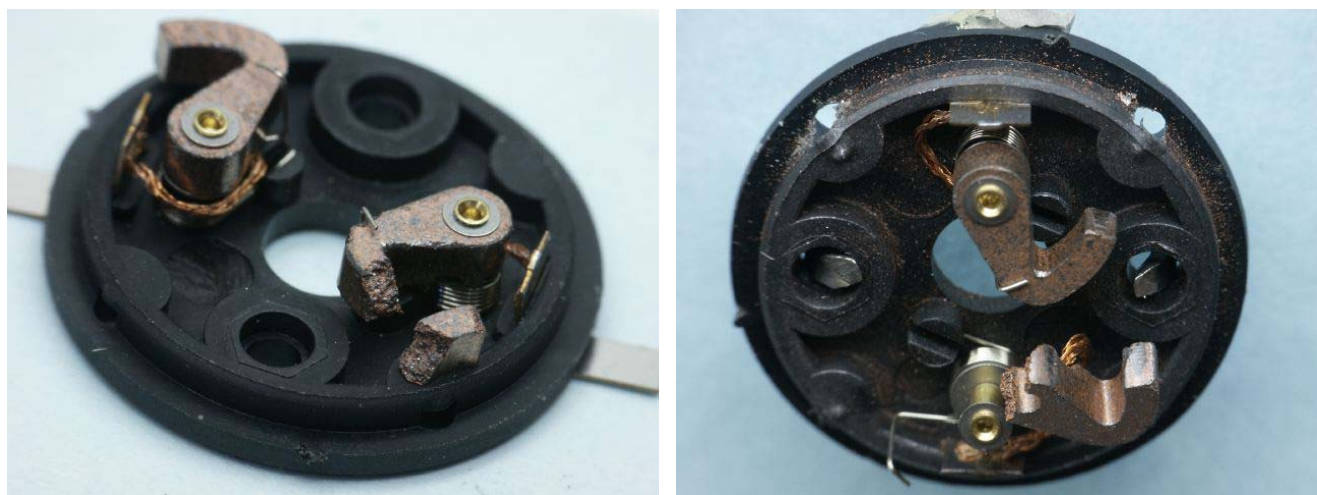
Figure 6.1-1. Motor Brush Anomalies – Tip Failure (Left) and Pivot Failure (Right)

The anomalies with these motors occur in the commutating brushes. There are two failure modes that have been identified which are a concern for mission success (shown in Figure 6.1-1).

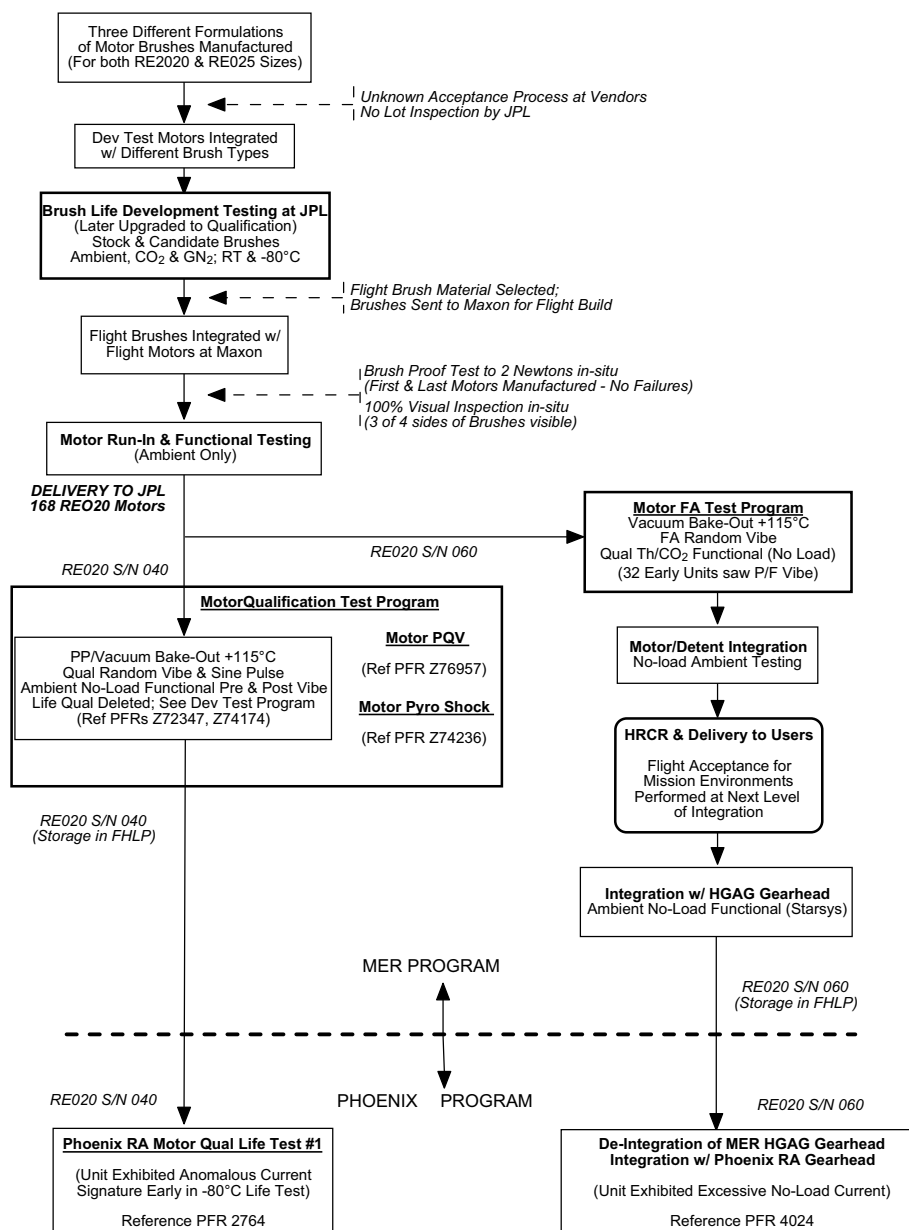
Figure 6.1-2. History of Failed Brush Motors S/N 040 and 060

In addition to the 50 RE020 units now on Mars, 17 units were used in the MER Project test bed. The remaining units were placed in storage under the Flight Hardware Logistics Program (FHLP). For the Phoenix Project, 28 of these motors were retrieved from FHLP, including serial numbers (S/Ns) 40 and 60 which were found to be defective with broken commutator brushes. Similar to other (26) motors pulled, these two motors were fully tested by the MER Project, but were not exposed to a shock environment before they were placed in FHLP. S/N 40 was one of the original four units that were part of the qualification program performed by the MER Project. S/N 60 was originally integrated into the MER Project flight spare high-gain-antenna gimbal (HGAG). S/N 60 was then de-integrated from the HGAG and assembled in the electron microscope autoradiography (EMRA) wrist. S/N 60 was replaced by S/N 101 after the motor failure was discovered during the Phoenix Project. No clear failure mechanism has been established for these two brush failures. It was suggested, but cannot be substantiated, that adverse handling may have precipitated the breakage. There appear to have been no special handling and storage procedures in place beyond the care normally exercised with flight hardware. Figure 6.1-2 illustrates the flow and processing of S/N 040 and 060.

Screening and Validation Testing of MER Brush Motors (Ref Phoenix PFRs 2764 & 4024)

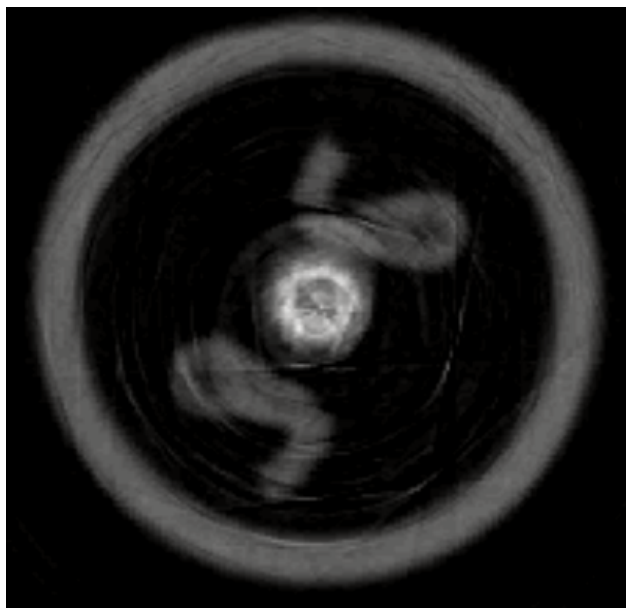
Figure 7.0-1. Image 6304 Motor N-Ray Image (Brushes Intentionally Not in Position)

Figure 7.0-1 (Image 6304) depicts the interior of a partial motor assembly (missing the encoder assembly). The brushes were intentionally installed incorrectly by not spring-preloading against the commutator. If N-ray could not detect this workmanship flaw, then it was doubtful N-ray would be beneficial as a rigorous nondestructive tool.

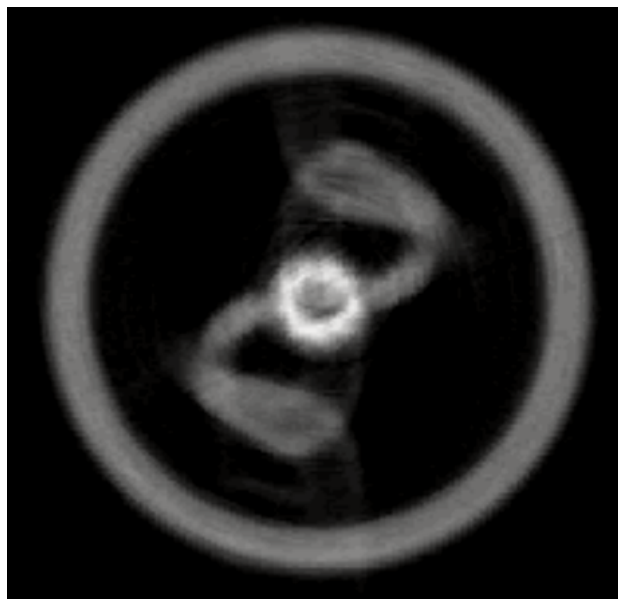
Figure 7.0-2. Image 6305 Motor N-Ray Image

Figure 7.0-2 (Image 6305) depicts a scan of a fully assembled motor with the encoder assembly included.

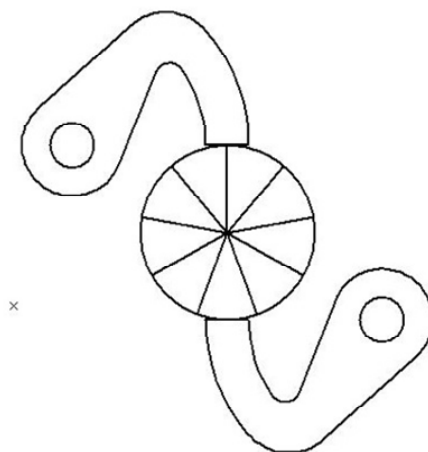
Figure 7.4-1. Brush Motor Armature/Commutator Design

operation, one brush would fail in bucking because the adhesion of the brush to the commutator was greater than the buckling strength of the cantilevered beam.

All of the Phoenix Project motors are designed for bi-directional operation. Both brush bodies are in shear/tension in one direction of rotation and in shear/compression in the other direction of rotation (assuming non-zero sliding friction). The hooked “arm” of both brushes depicted in Figure 7.4-1 is bending at the “elbow” in either direction of rotation.

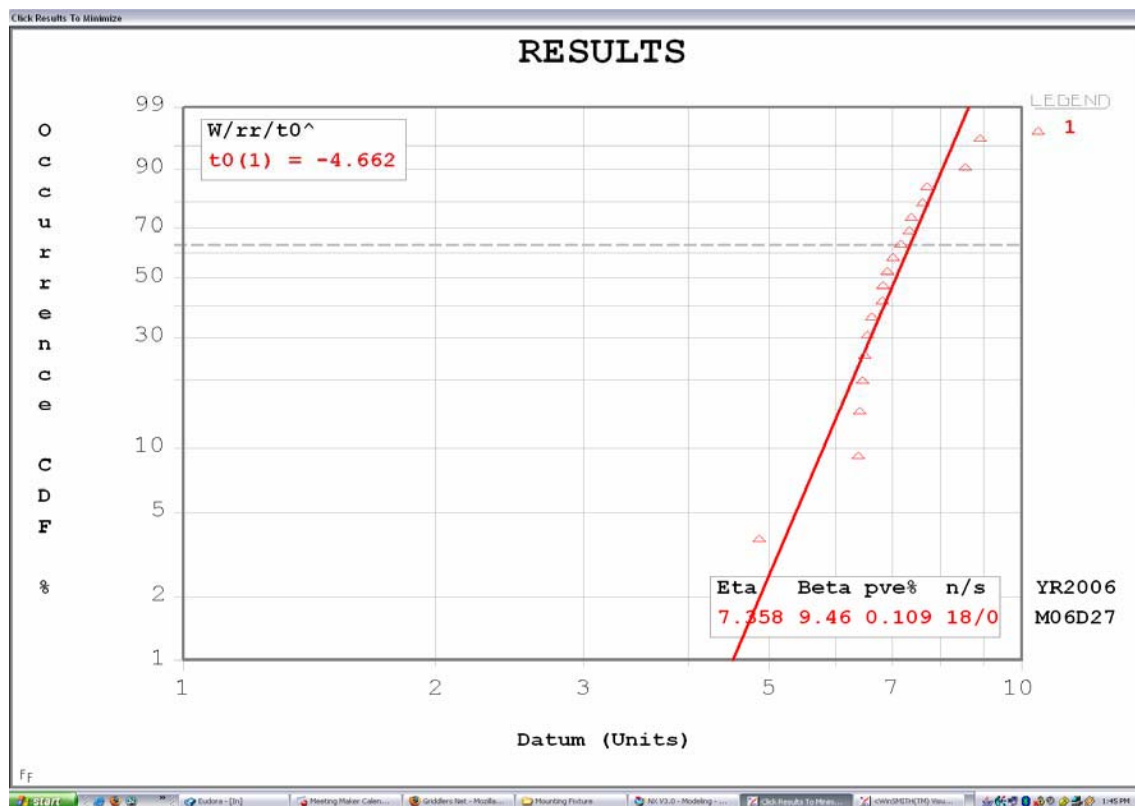
Figure 1. Three Parameter Weibull with Outlier

As shown on the plot, the data fit, defined by the pve%, is 0.190 which is not acceptable for analysis. The software package used to perform the statistical analysis (Weibull 4.0) indicated that sample number 1 of batch 1, the brush that failed at a load of 0.196 pound, was an outlier and should be discarded from the data set.

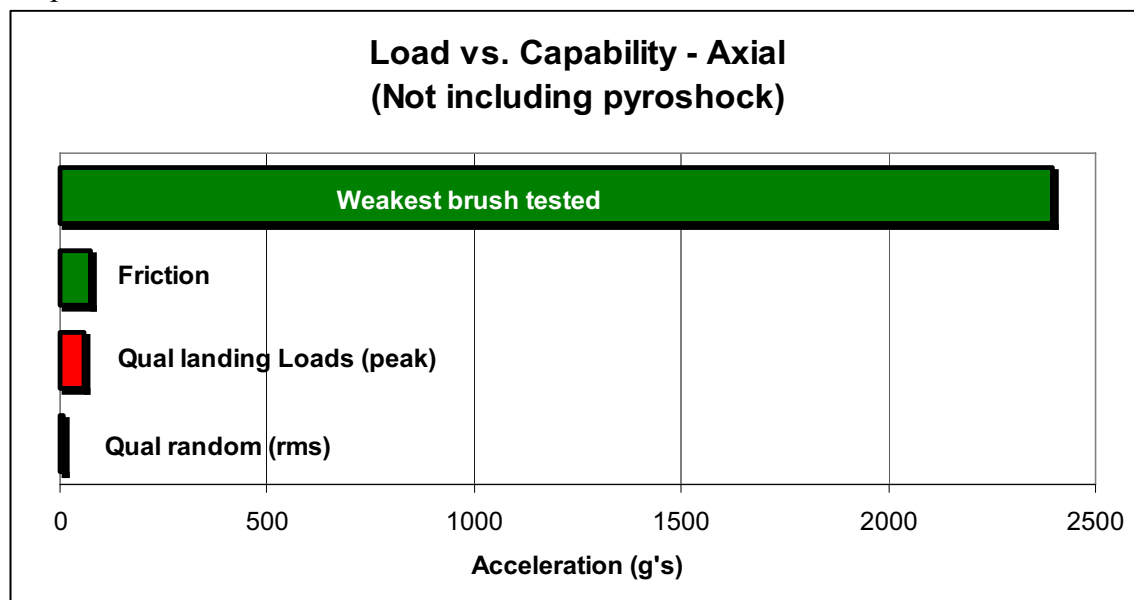
With the exception of pyroshock and other impact loads, the brush strengths measured are well in excess of any environmental loads imposed.
